# MicroScope Processed eCaliper

## C0026A

6956.1 - 7393.7m (MD 1:200)

COMPANY: JAMSTEC

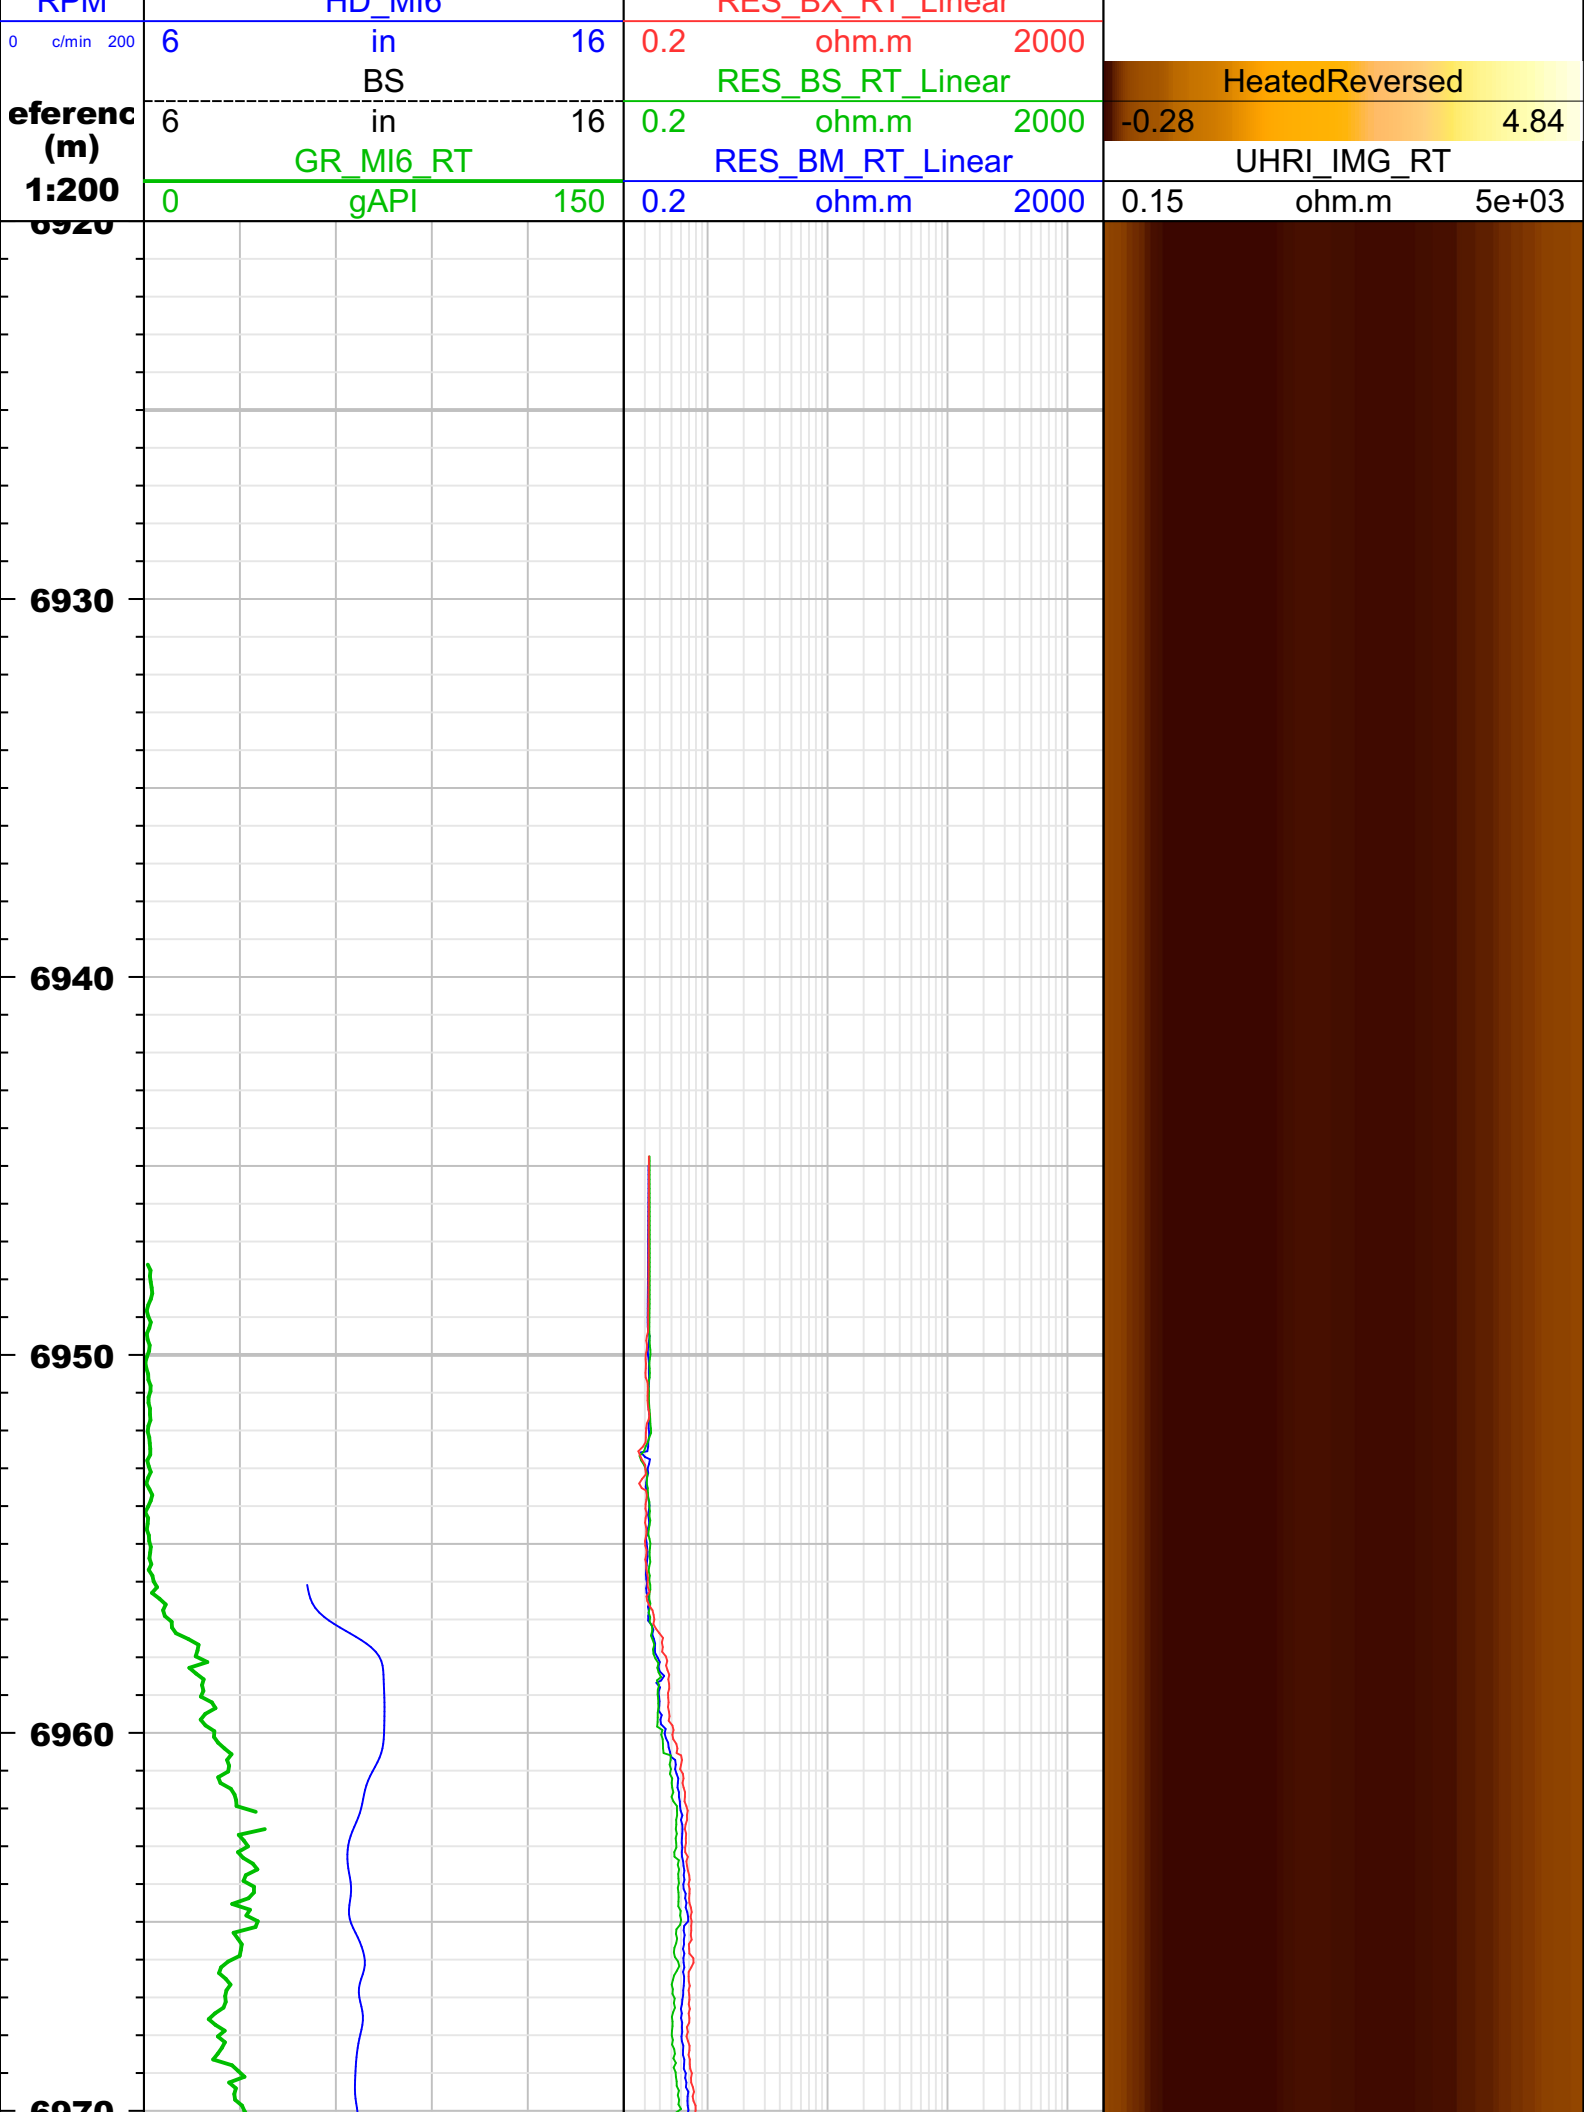
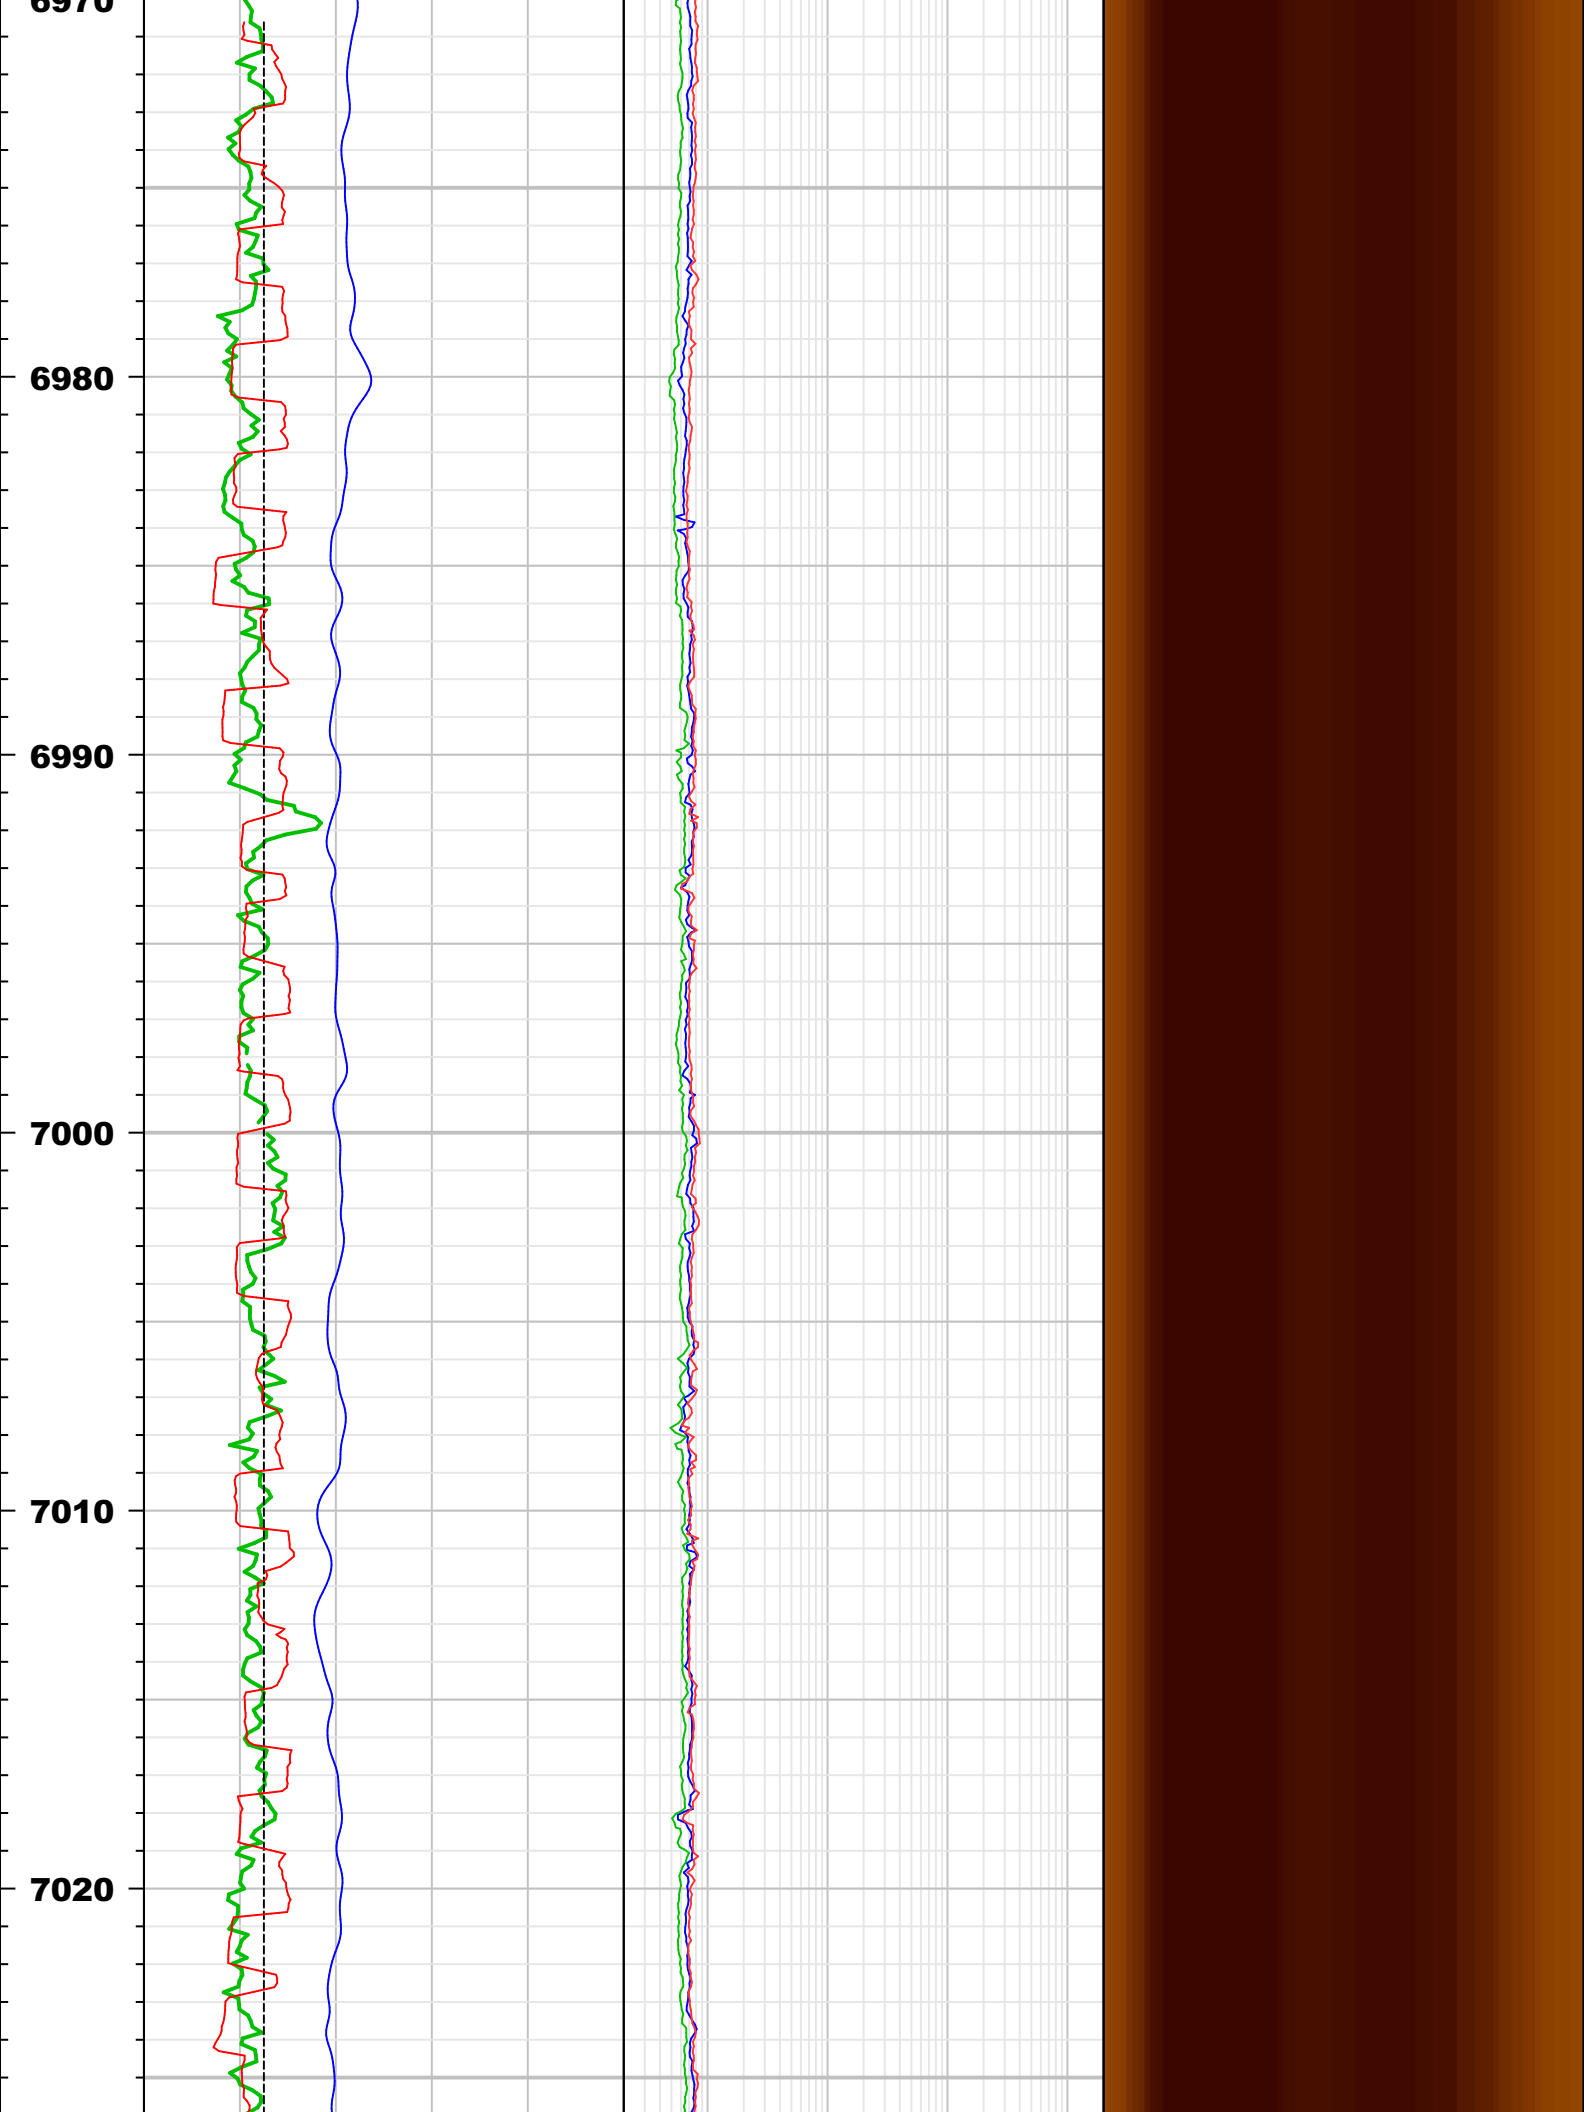
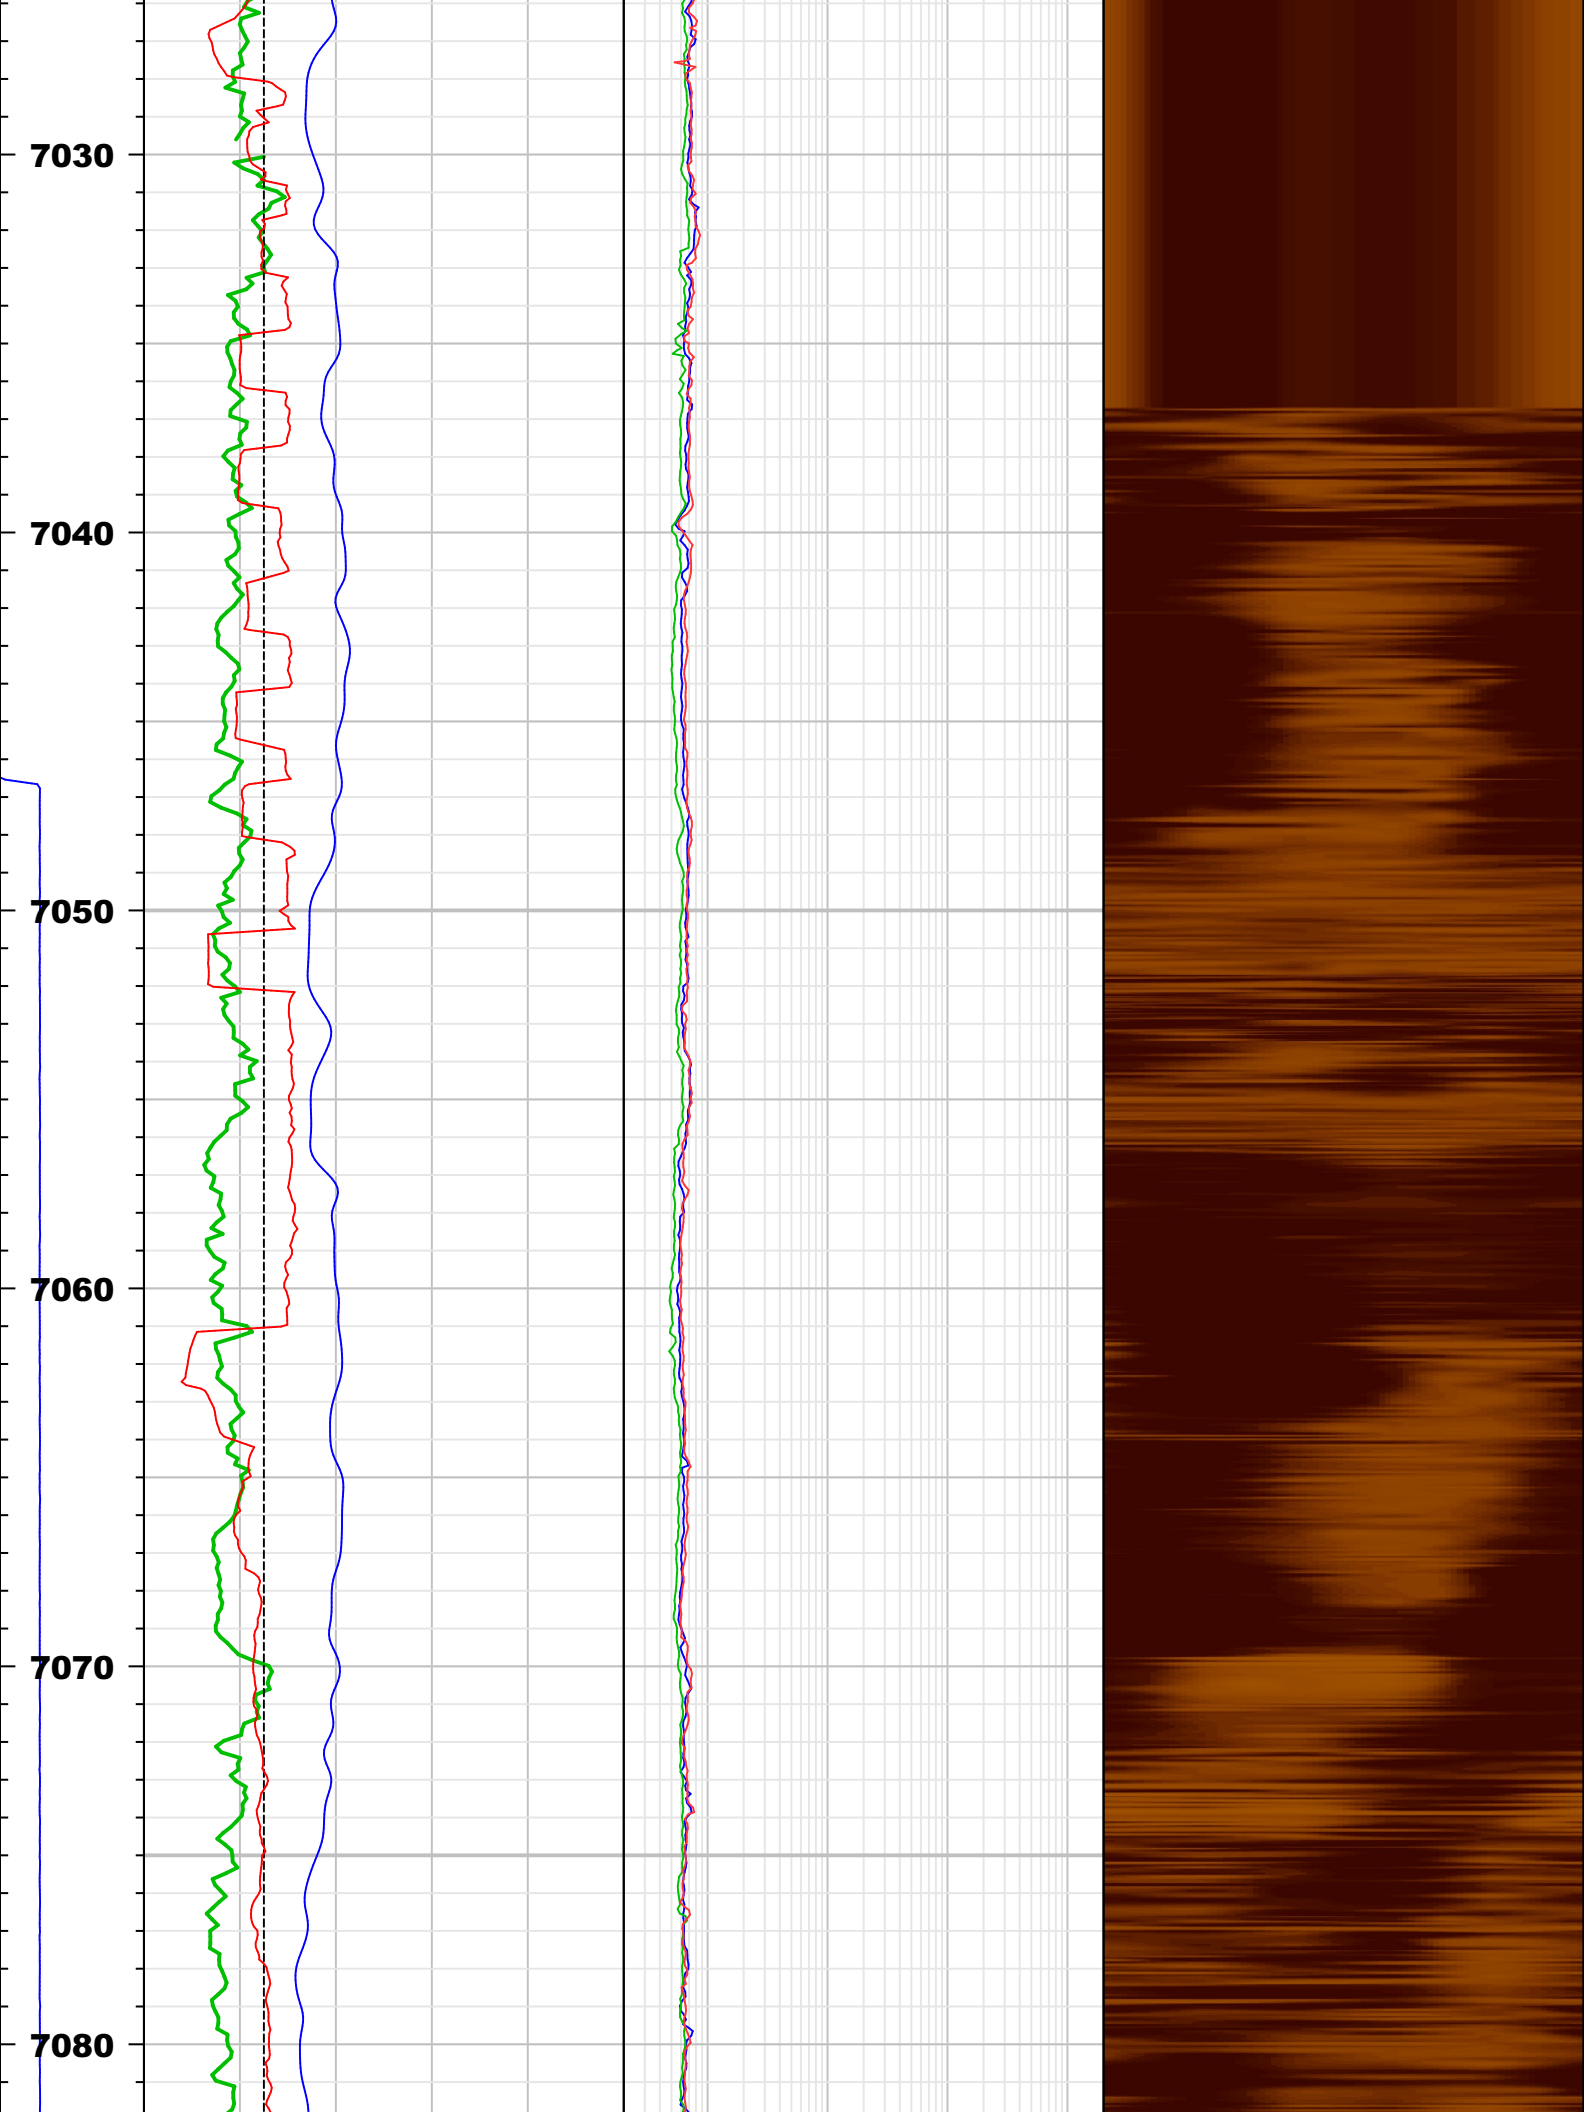
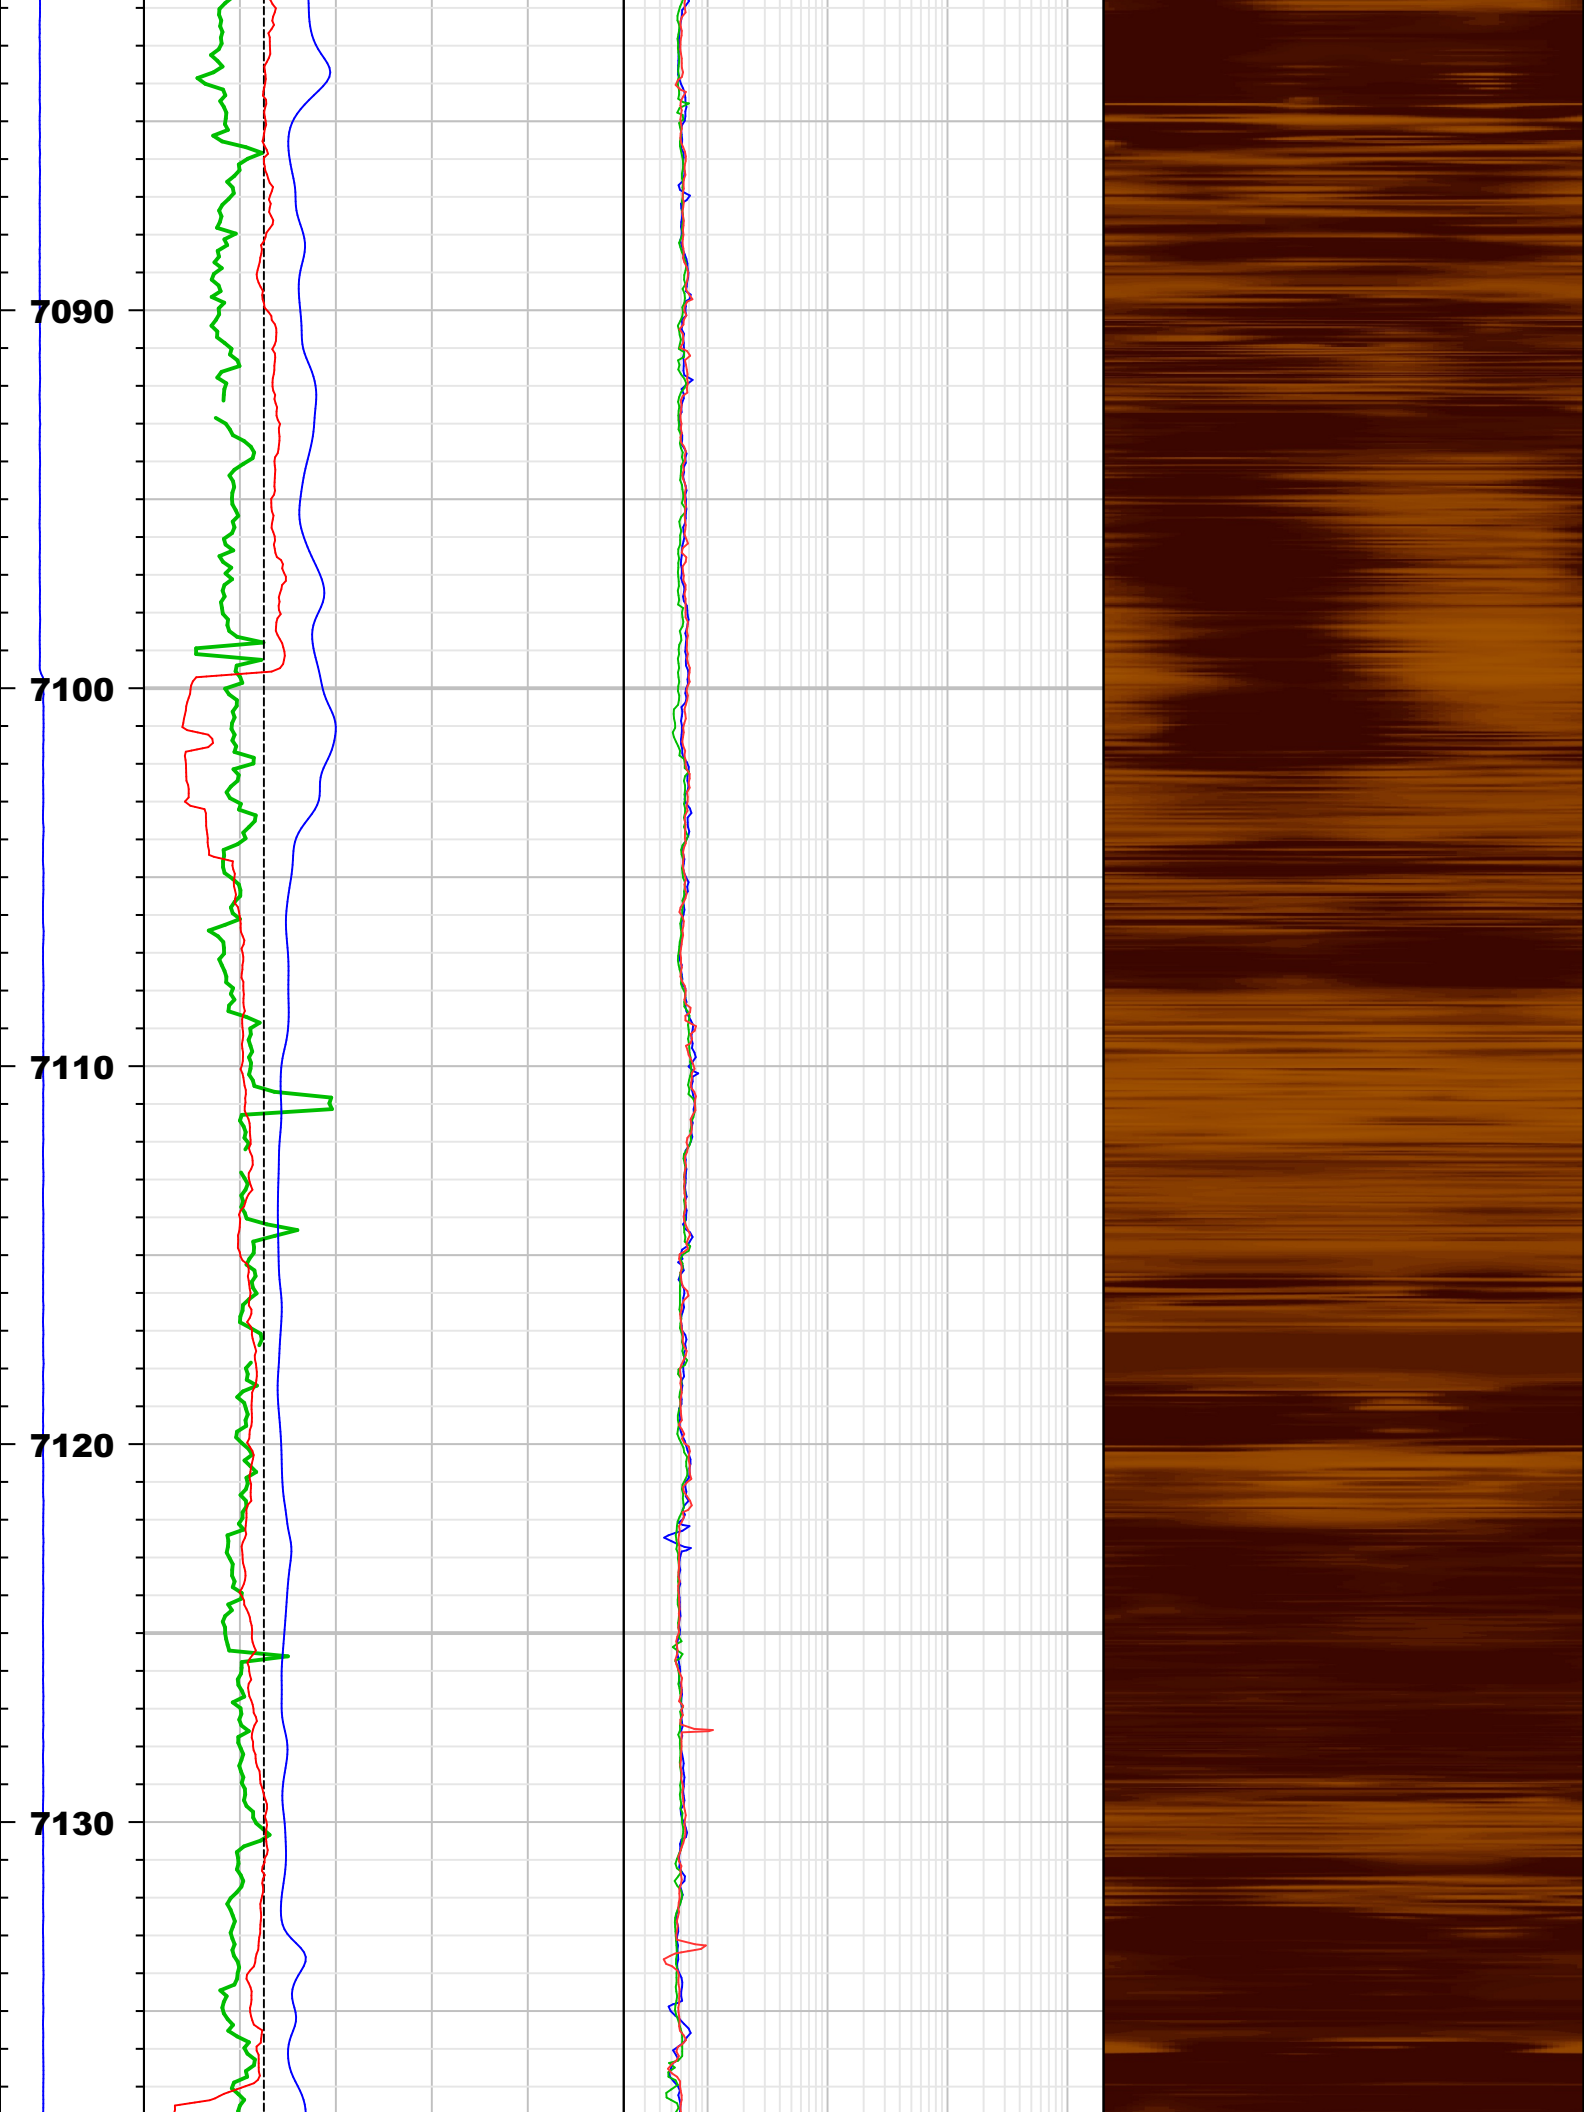
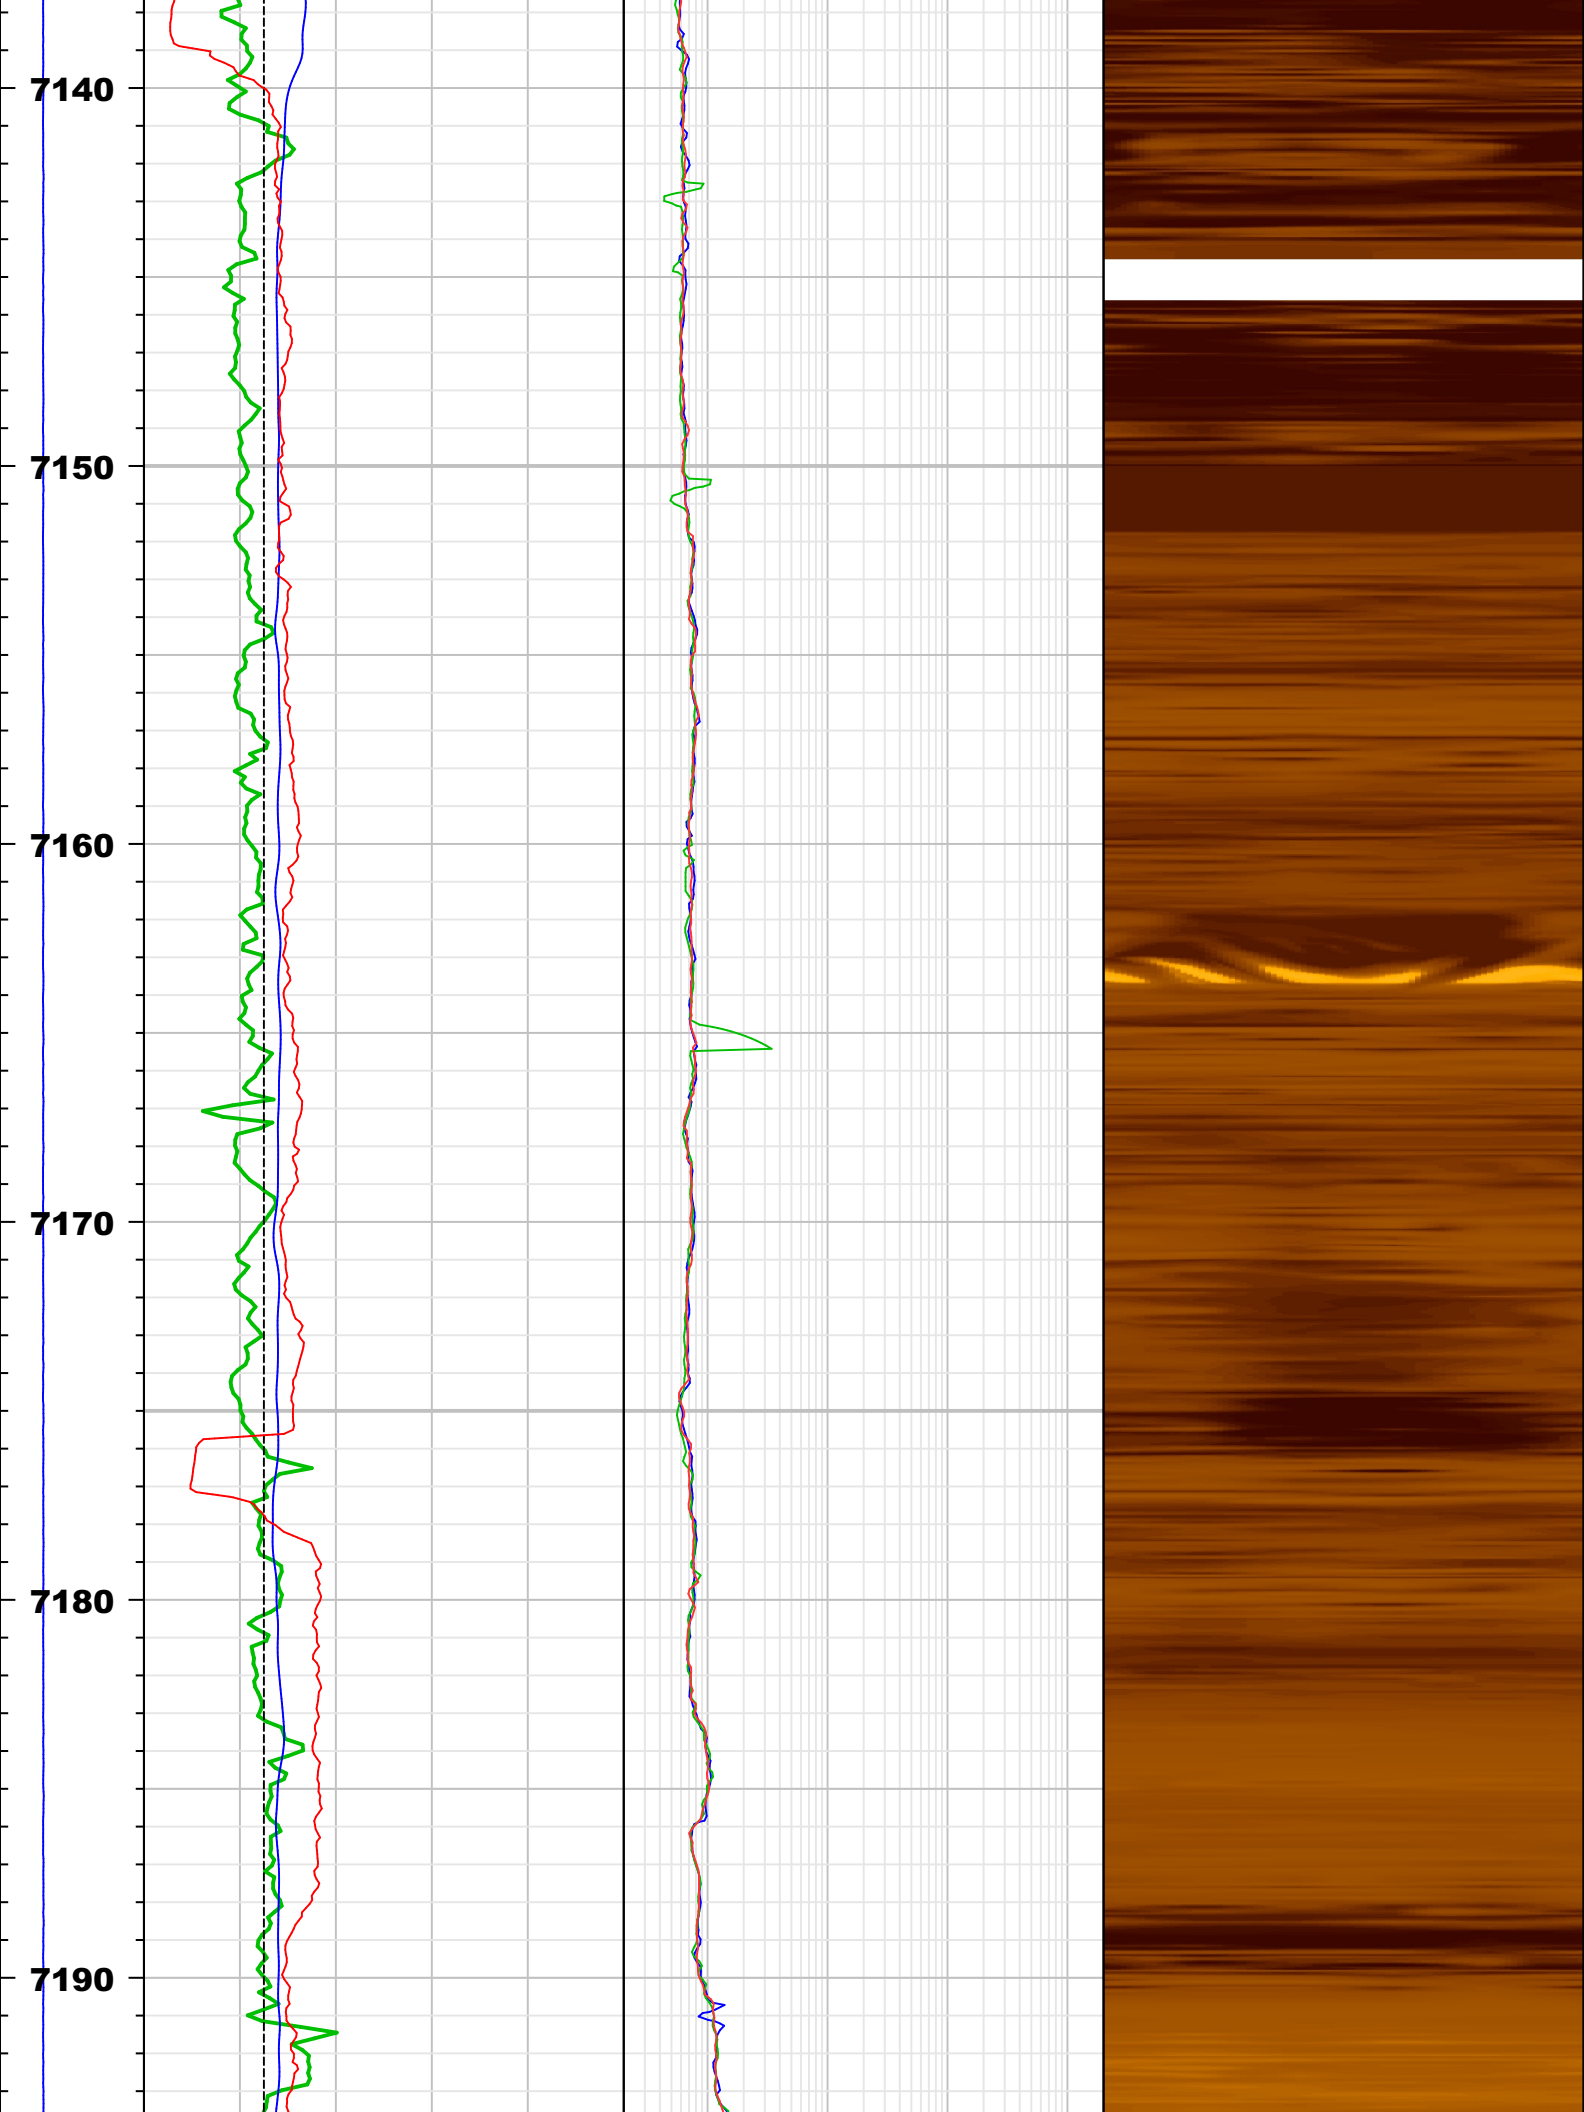
- This is 8.5in section drilling pass processed MicroScope eCaliper.
- Data presented is Real Time data.
- Permanent Datum: Mean Sea Level, Logging Measured from Drill Floor.
- HD\_M16 is eCaliper result from MicroScope
- HD\_M16 around 7203mMD-7319mMD is very high uncertainty and hard to check with UHRI image, because UHRI image is not continuous, and resistivity curves are very spike and lots despiking and linear interpolation were performed
- eCaliper is used to qualitative identification of borehole condition. The accuracy of the eCaliper is hard to guarantee.

| RPM<br>0 c/min 200 | ROP5 | | | RES_BX_RT_Linear<br>0.2 ohm.m 2000<br>RES_BS_RT_Linear<br>0.2 ohm.m 2000<br>RES_BM_RT_Linear<br>0.2 ohm.m 2000 | HeatedReversed<br>-0.28 4.84<br>UHRI_IMG_RT<br>0.15 ohm.m 5e+03 |
